planning
architecture
culture & heritage

MANUAL TRAINING & HOME ECONOMICS BUILDING HERITAGE ASSESSMENT

October 2013

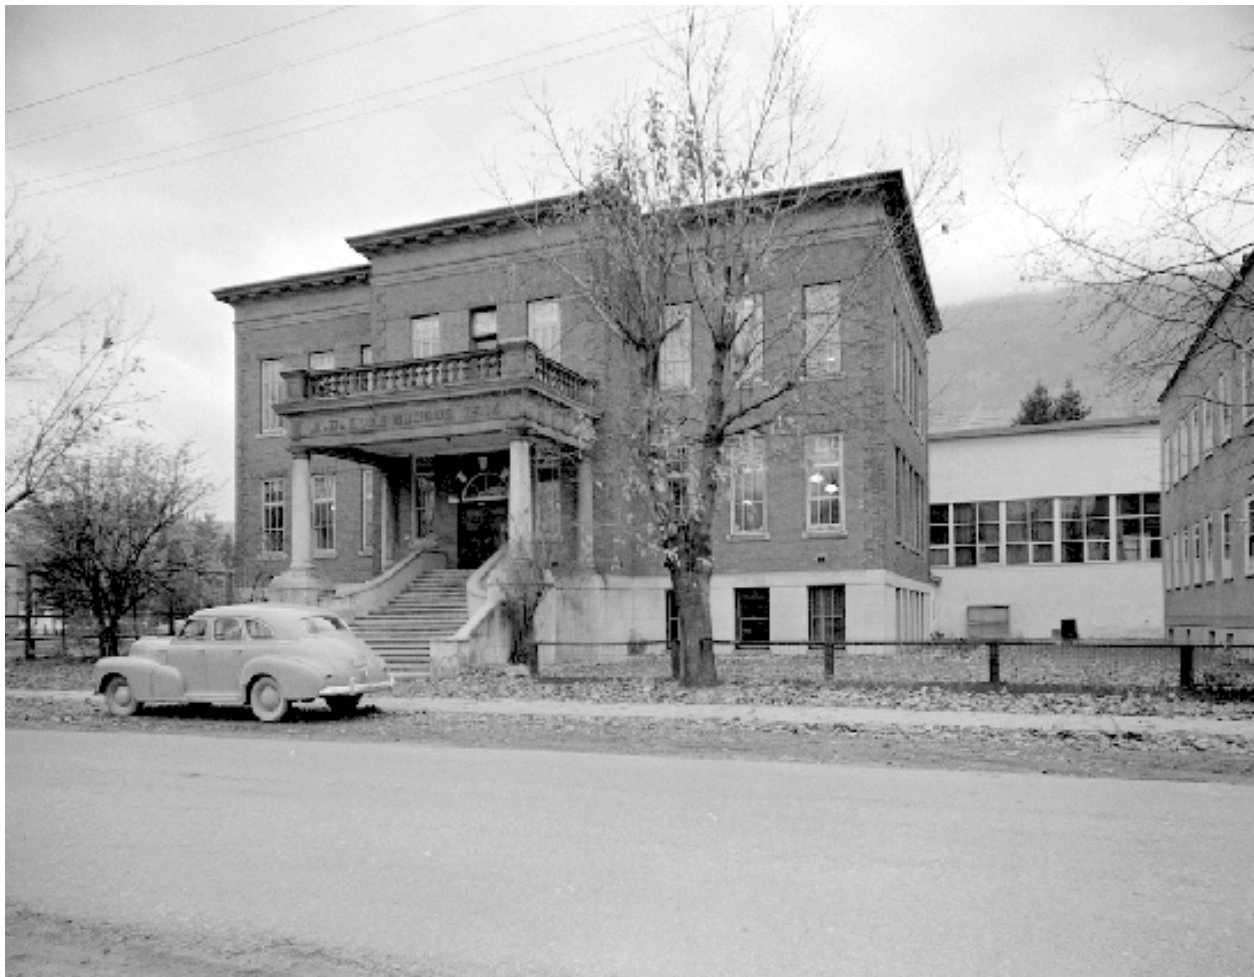
Mountain View School, 1952; Manual Training School at extreme right. [British Columbia Archives I-22765]
