***Physical Processes of Water
and the Ecological Effects of
Peaking Plant
and Reservoir Operations
At Revelstoke, B.C.***

January 22, 2014

Francis L. Maltby

Accelerated Erosion and Hydrological Impacts of Revelstoke Peaking Plant operations

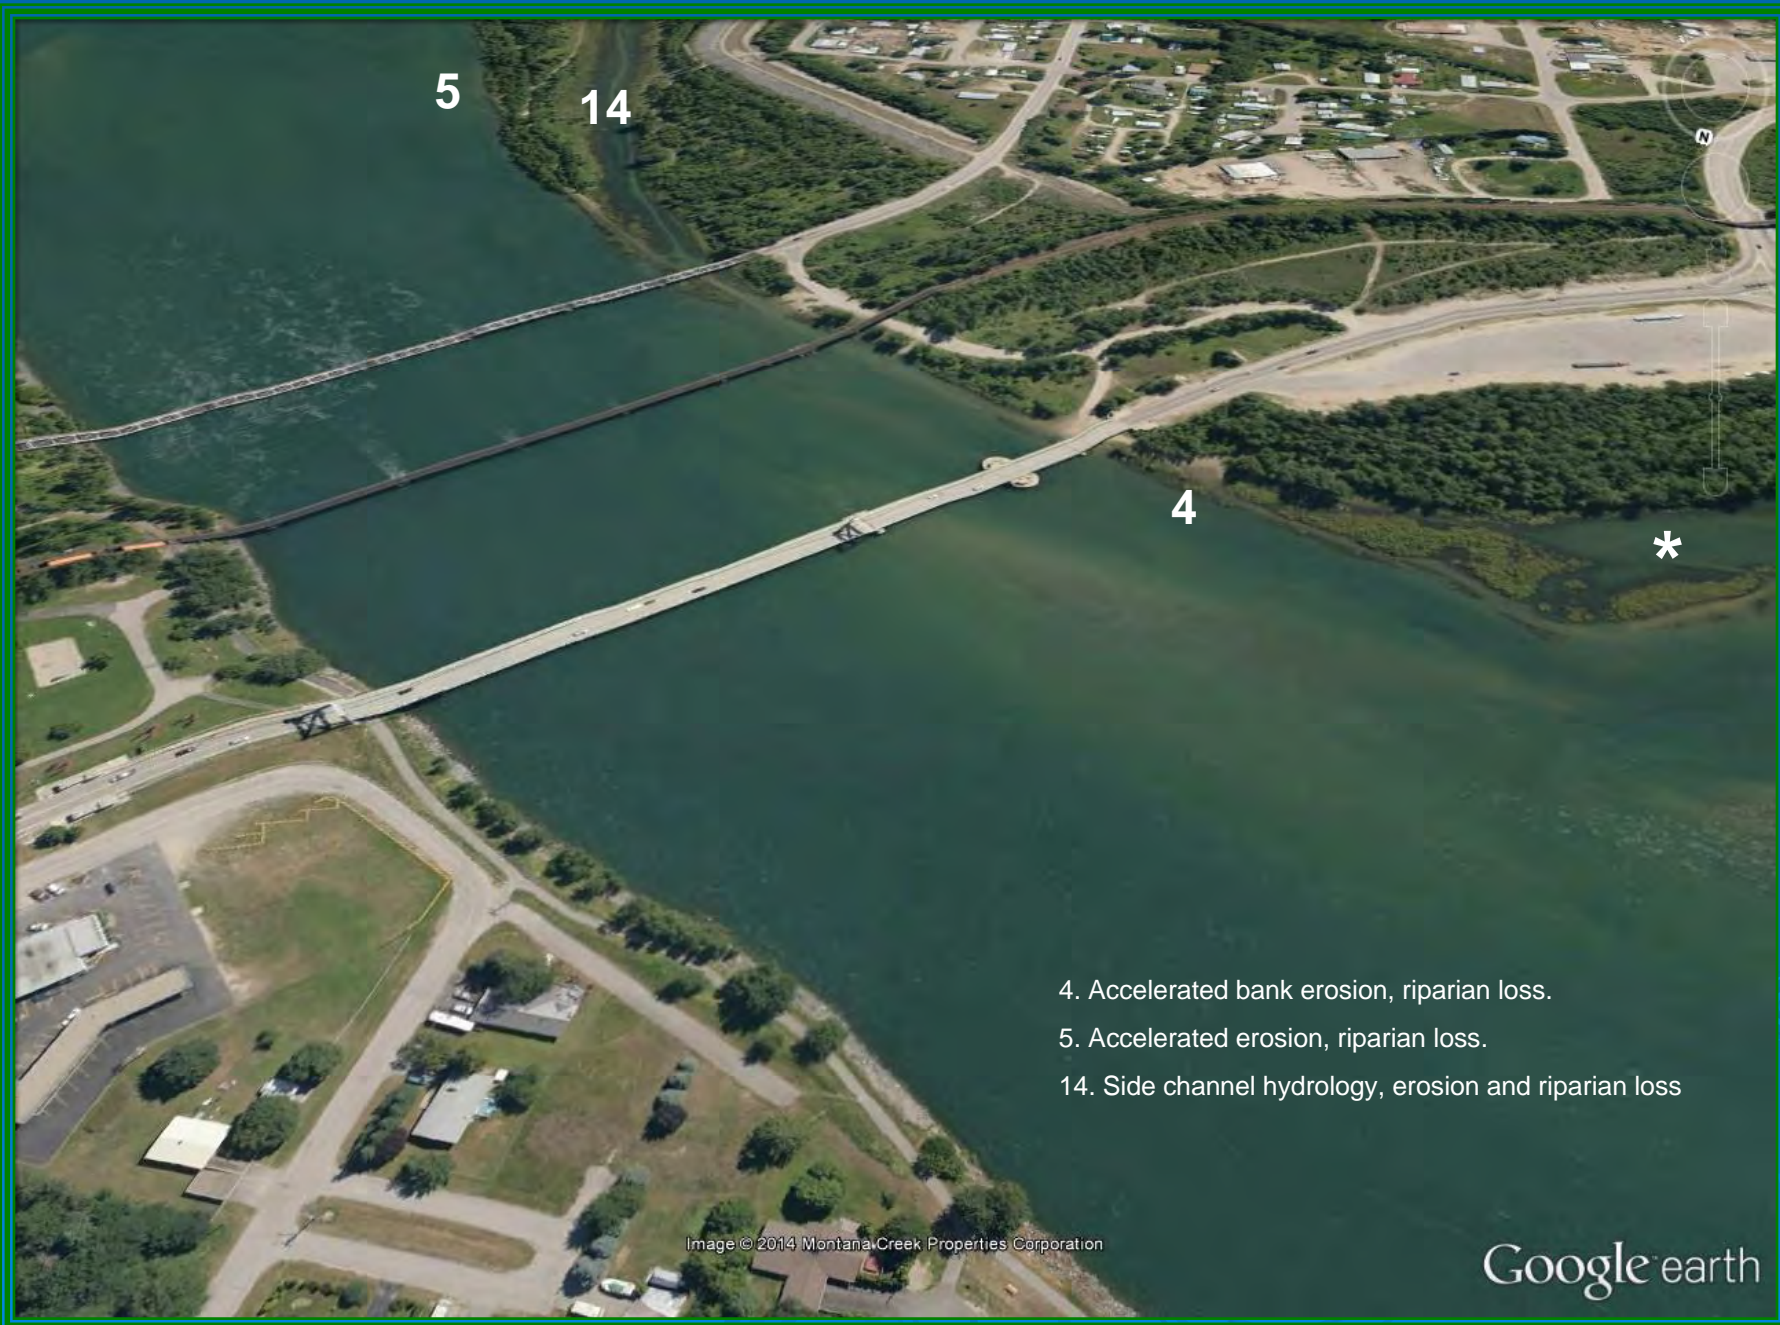
1. Revelstoke Dam
2. Channel excavation for turbine efficiency (approximate location)
 - 2a. sediment deposit from #2.
 - 2b. sediment deposit from #2.
3. Revelstoke Golf Course.
4. Accelerated erosion, riparian loss.
5. Accelerated erosion, riparian loss.
6. Nesting islands erosion.
7. Channel incision, rip rap Cent. Park.
8. Accelerated erosion, riparian loss.
9. Downie Marsh, hydrology.
10. IGS Nature Park Water Study.
11. Channel incision.
 - 11a. Wetland draining (fall).
- 12-12a. Locke Creek, hydrology, erosion and sedge habitat loss.
- 13-13a. Cartier Marsh, hydrology
14. Side channel, hydrology, erosion and riparian loss.

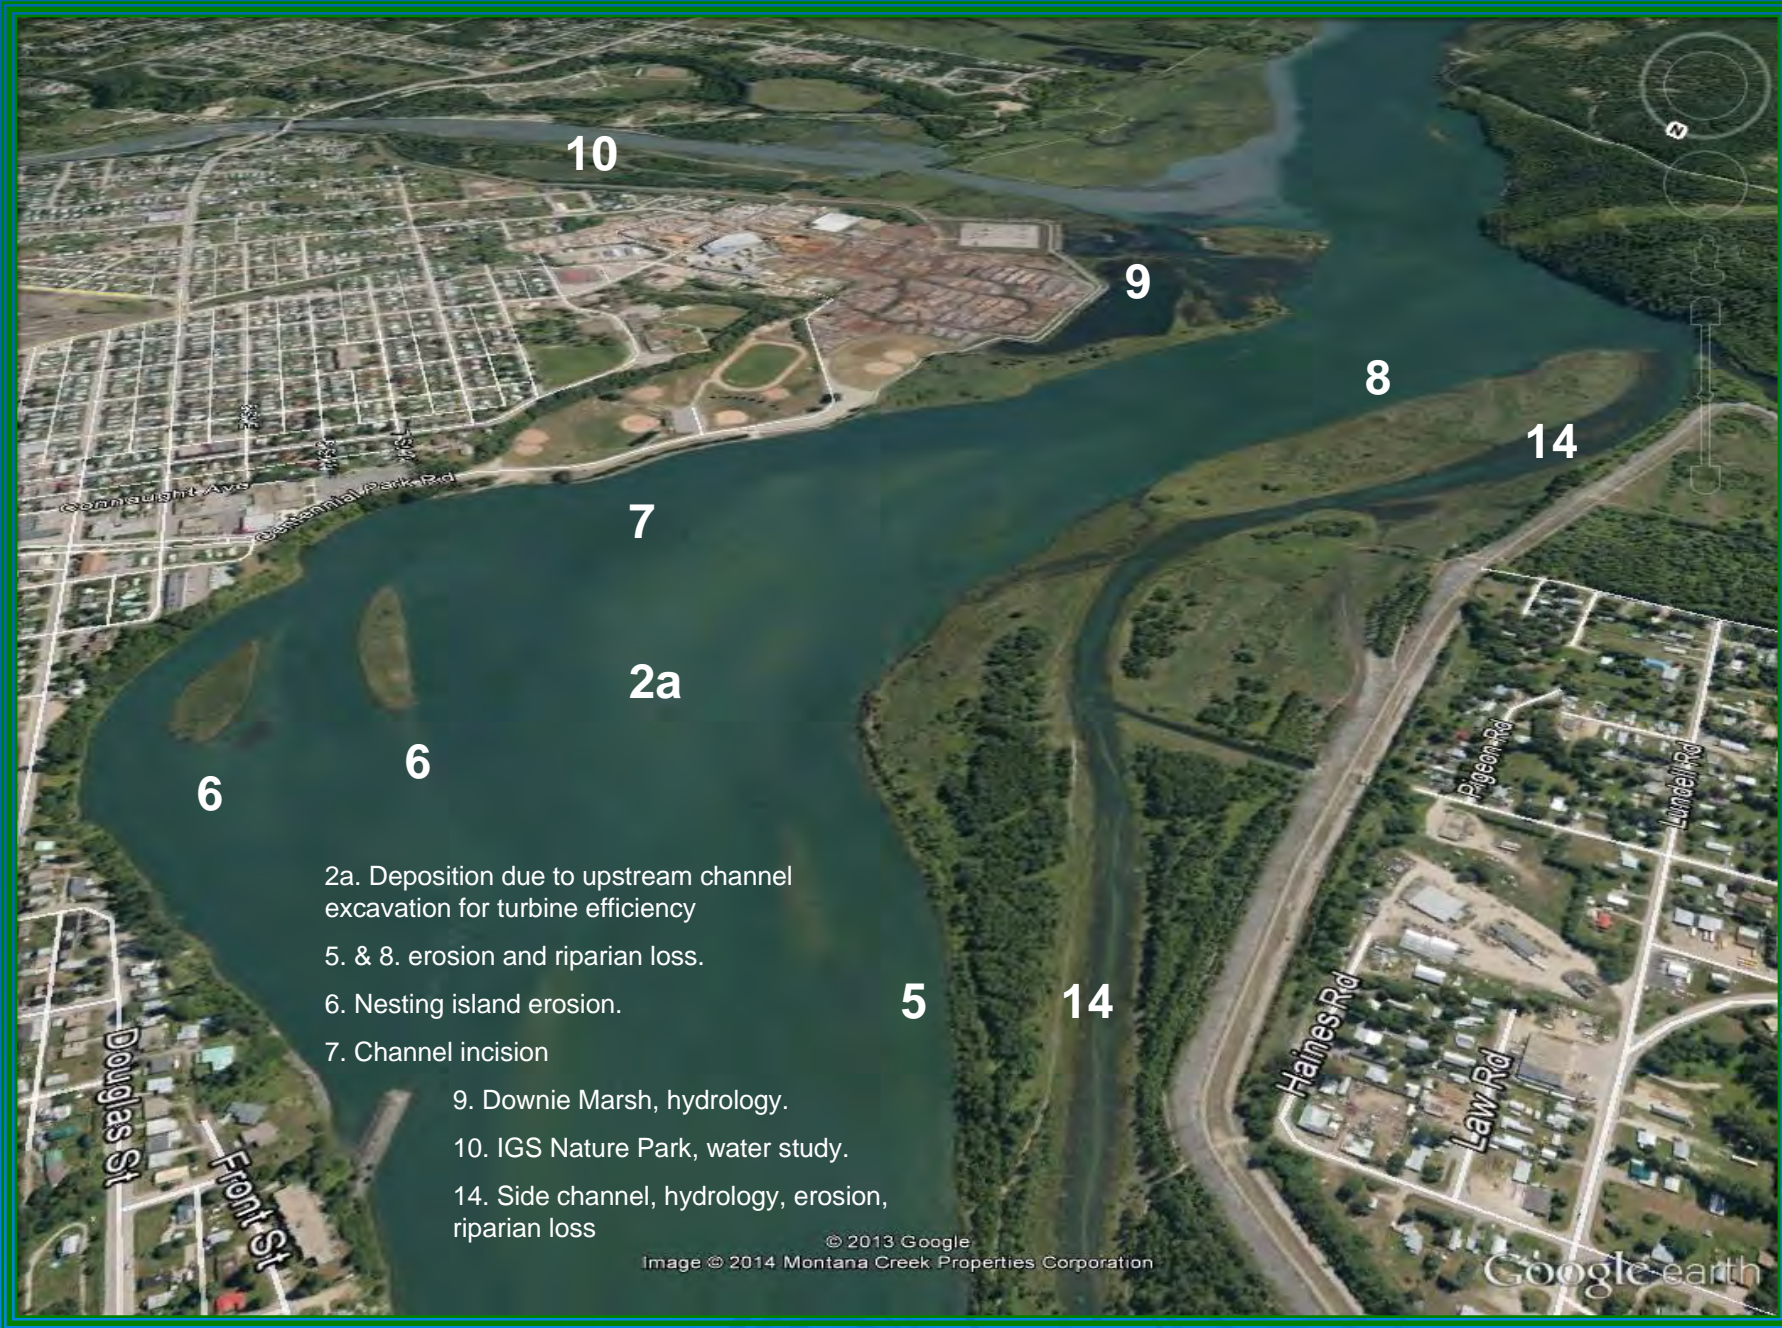
- 4. Accelerated bank erosion, riparian loss.
- 5. Accelerated erosion, riparian loss.
- 14. Side channel hydrology, erosion and riparian loss

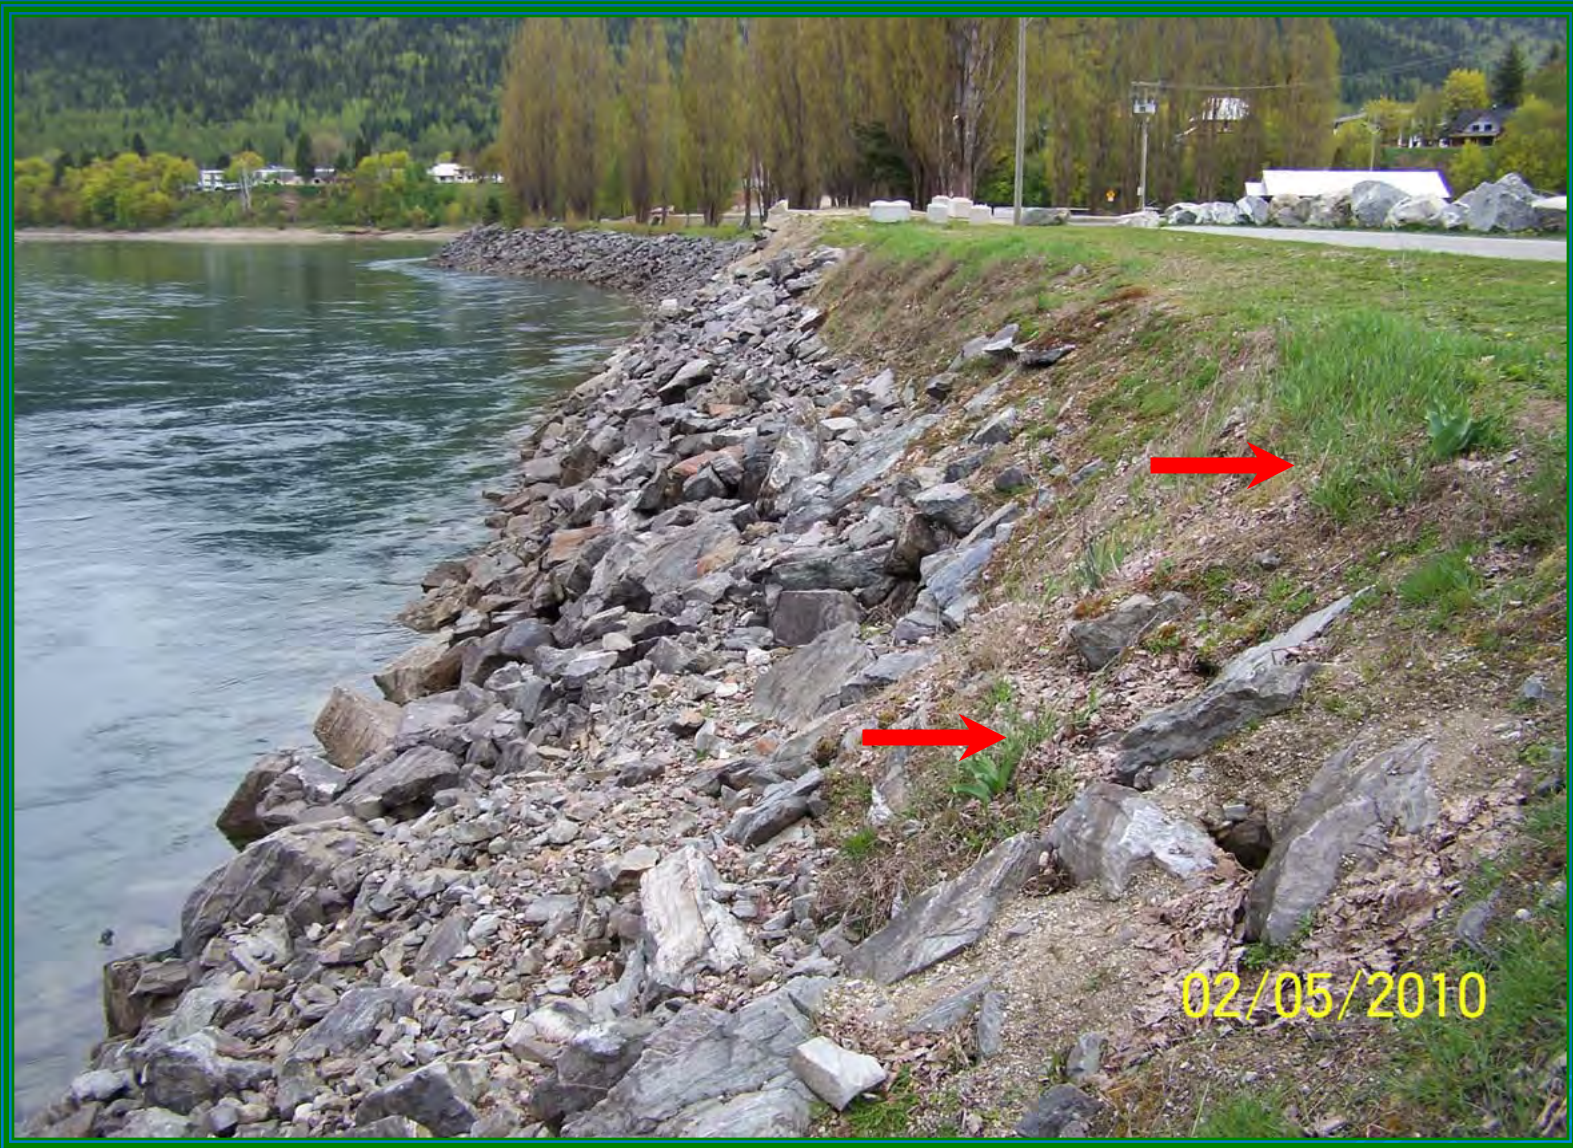
7. Channel incision, Centennial Park rip-rap

#7 : Incision Centennial Park as channel has deepened the rip-rap bank armouring has settled into the river channel.

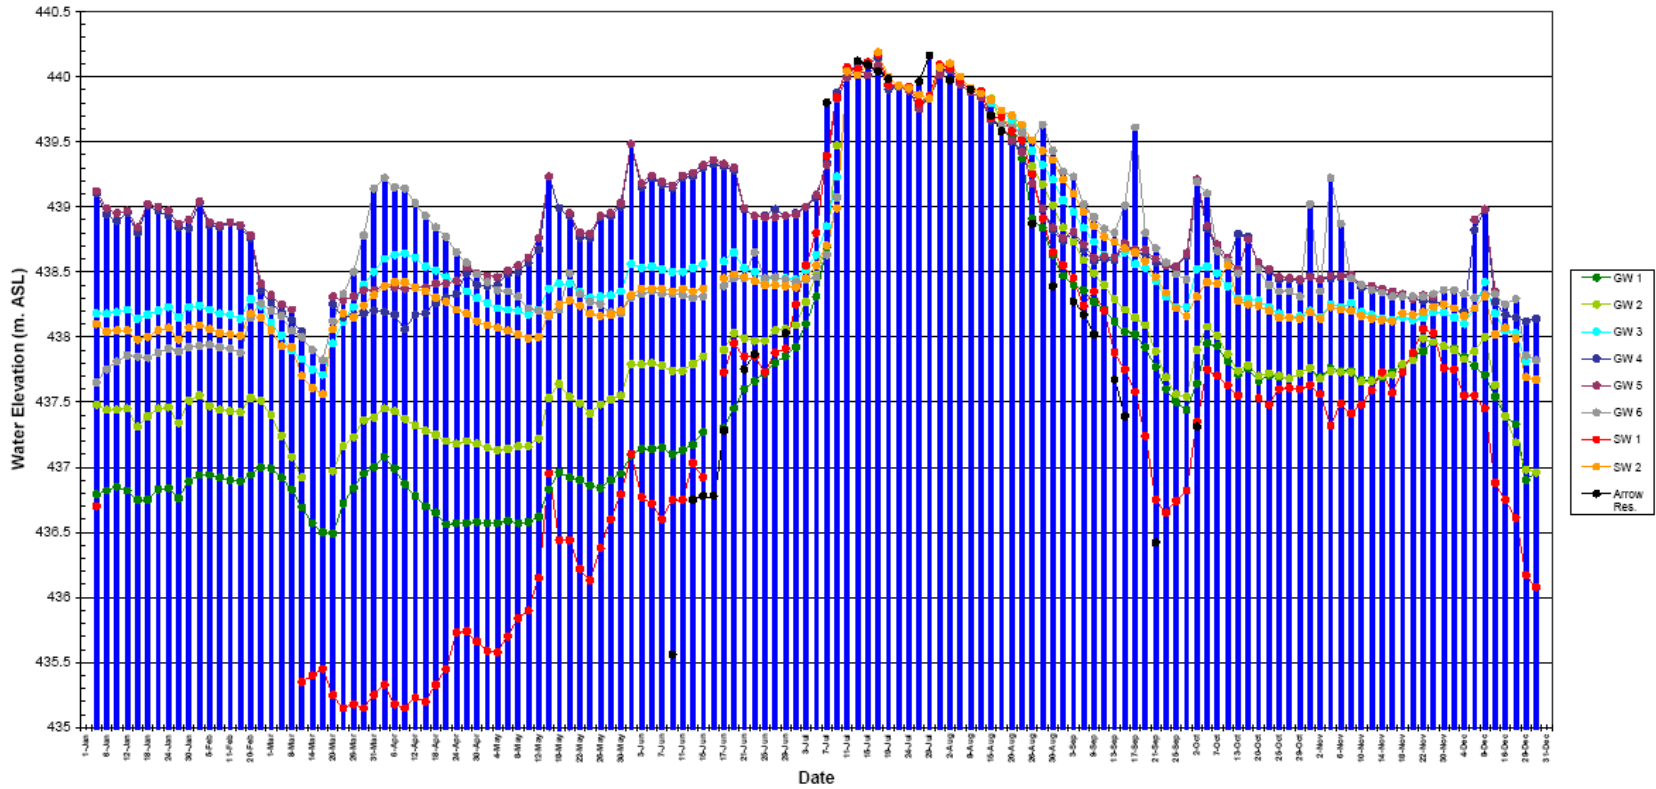
Illecillewaet Greenbelt Nature Park – Water Study 1996 - 1998

Spring – upslope drainage

Early summer – river fluctuations, NOTE: effects inland / permeability

Mid summer – Arrow reservoir levels

IGS Ground and Surface Water 1997

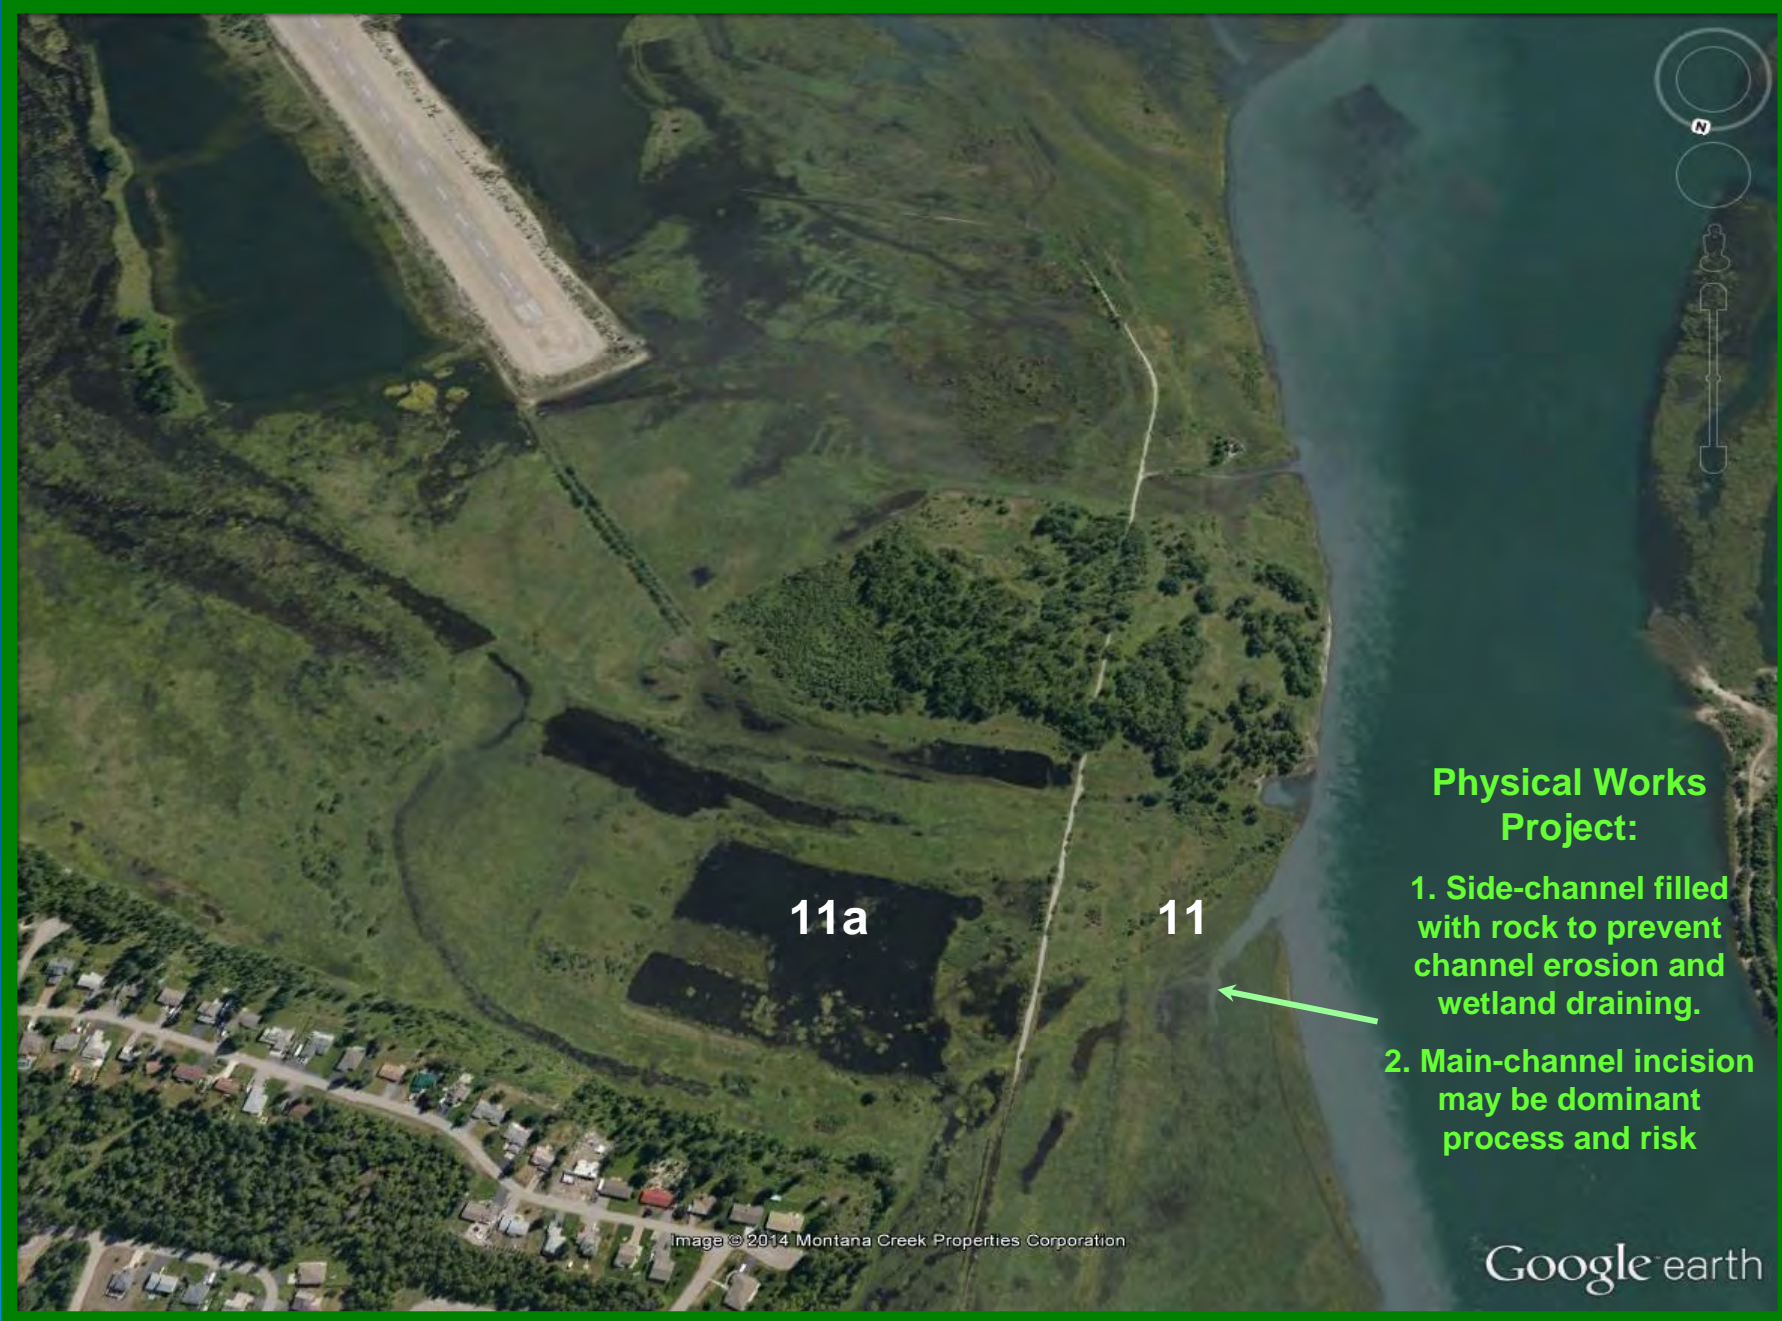
Illecillewaet Greenbelt Nature Park – Water Study
Annual Surface and Ground water hydrograph for 1997

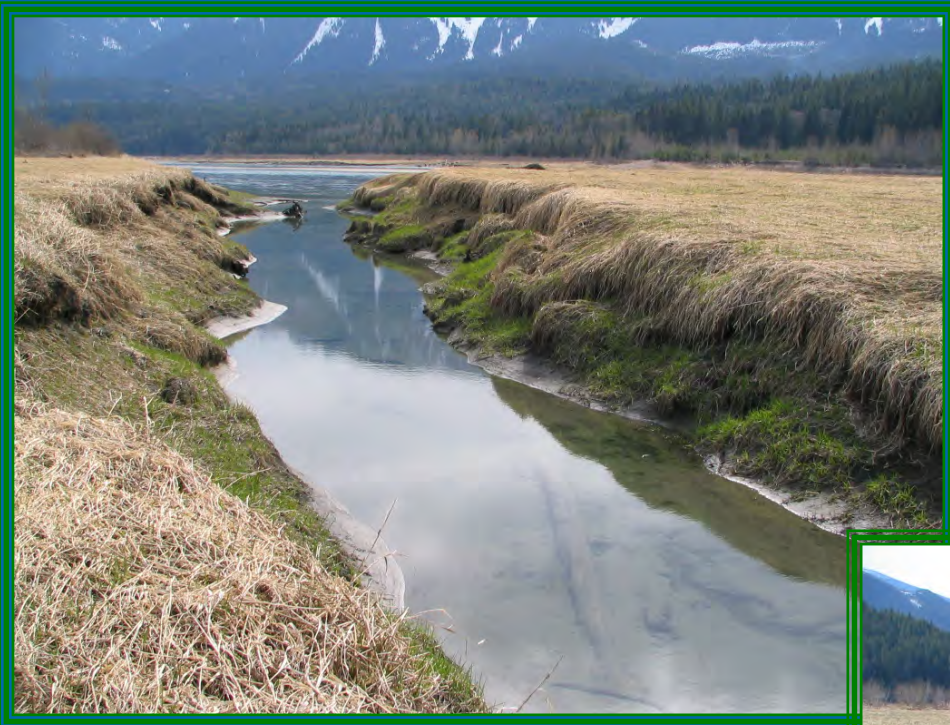
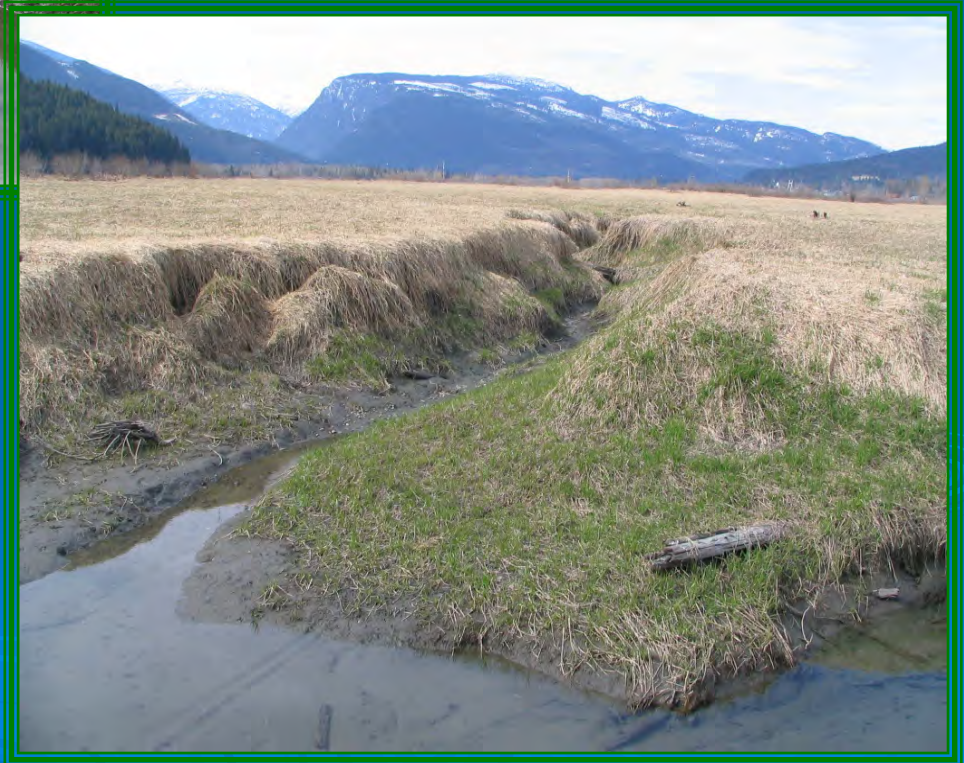
Northwest Airport Marsh outlet
channel (seasonal flow)
April 28, 2008

Physical Works Project:

- 1. Side-channel filled with rock to prevent channel erosion and wetland draining.
- 2. Main-channel incision may be dominant process and risk

Arrow res. 431.05m @ Nakusp

Rev. avr.day.dis. 16.9 kcfs

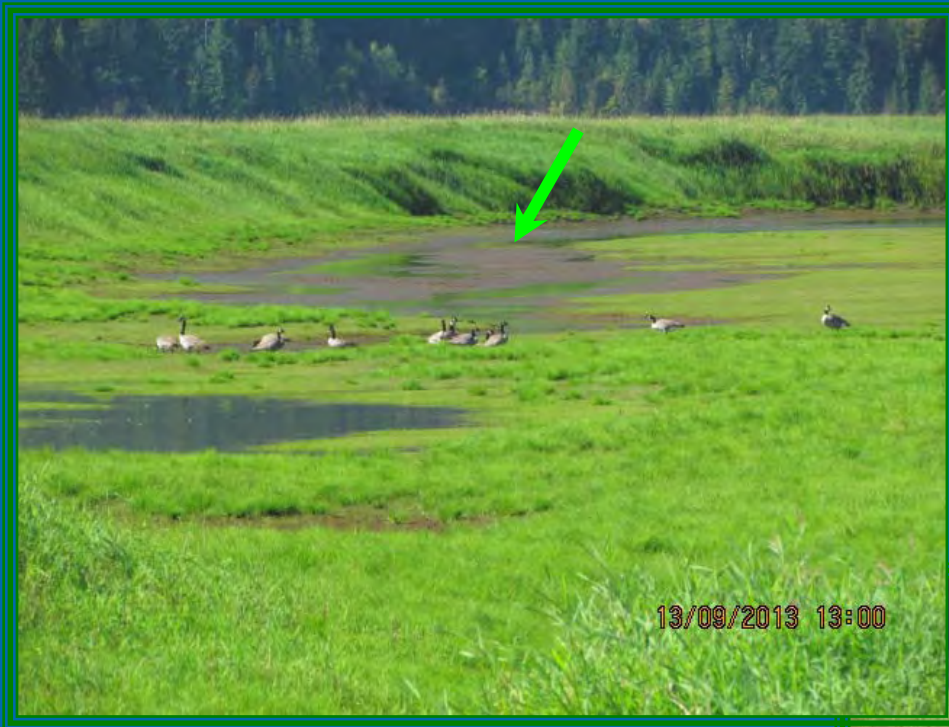
Lower Locke Creek

- Sedge flats, flood tolerant to a point, annual flood duration limits apparent.
- This species of sedge **occurs in a relatively narrow elevational band (~ 1.5 - 2m) within the Arrow Reservoir.** I have not found it abundant above or below that band.
- Sedge is a **very valuable food resource for migratory and resident waterfowl**, including support of rearing young.
- **Sedge losses likely occurring due to: prolonged inundation, unnatural exposure to freezing temperatures, overland and bank erosion processes**
- **All of these unnatural factors are caused by peaking plant operations.**

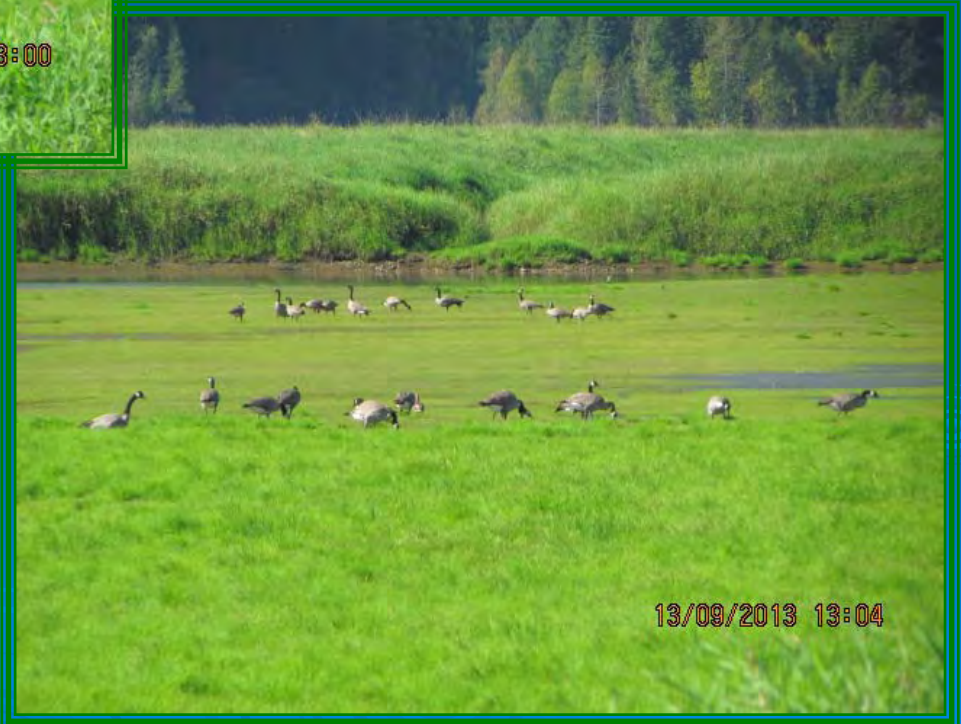
Upper Locke Creek

Sedge flats are a very valuable food resource and heavily utilized. Sedge flats here and elsewhere supports both resident nesting and migratory birds.

Note: Veg. free area.

While Sedge is flood tolerant, permanently saturated soil does not support sedge growth. Extending saturation (or flooding) period may reduce sedge cover.

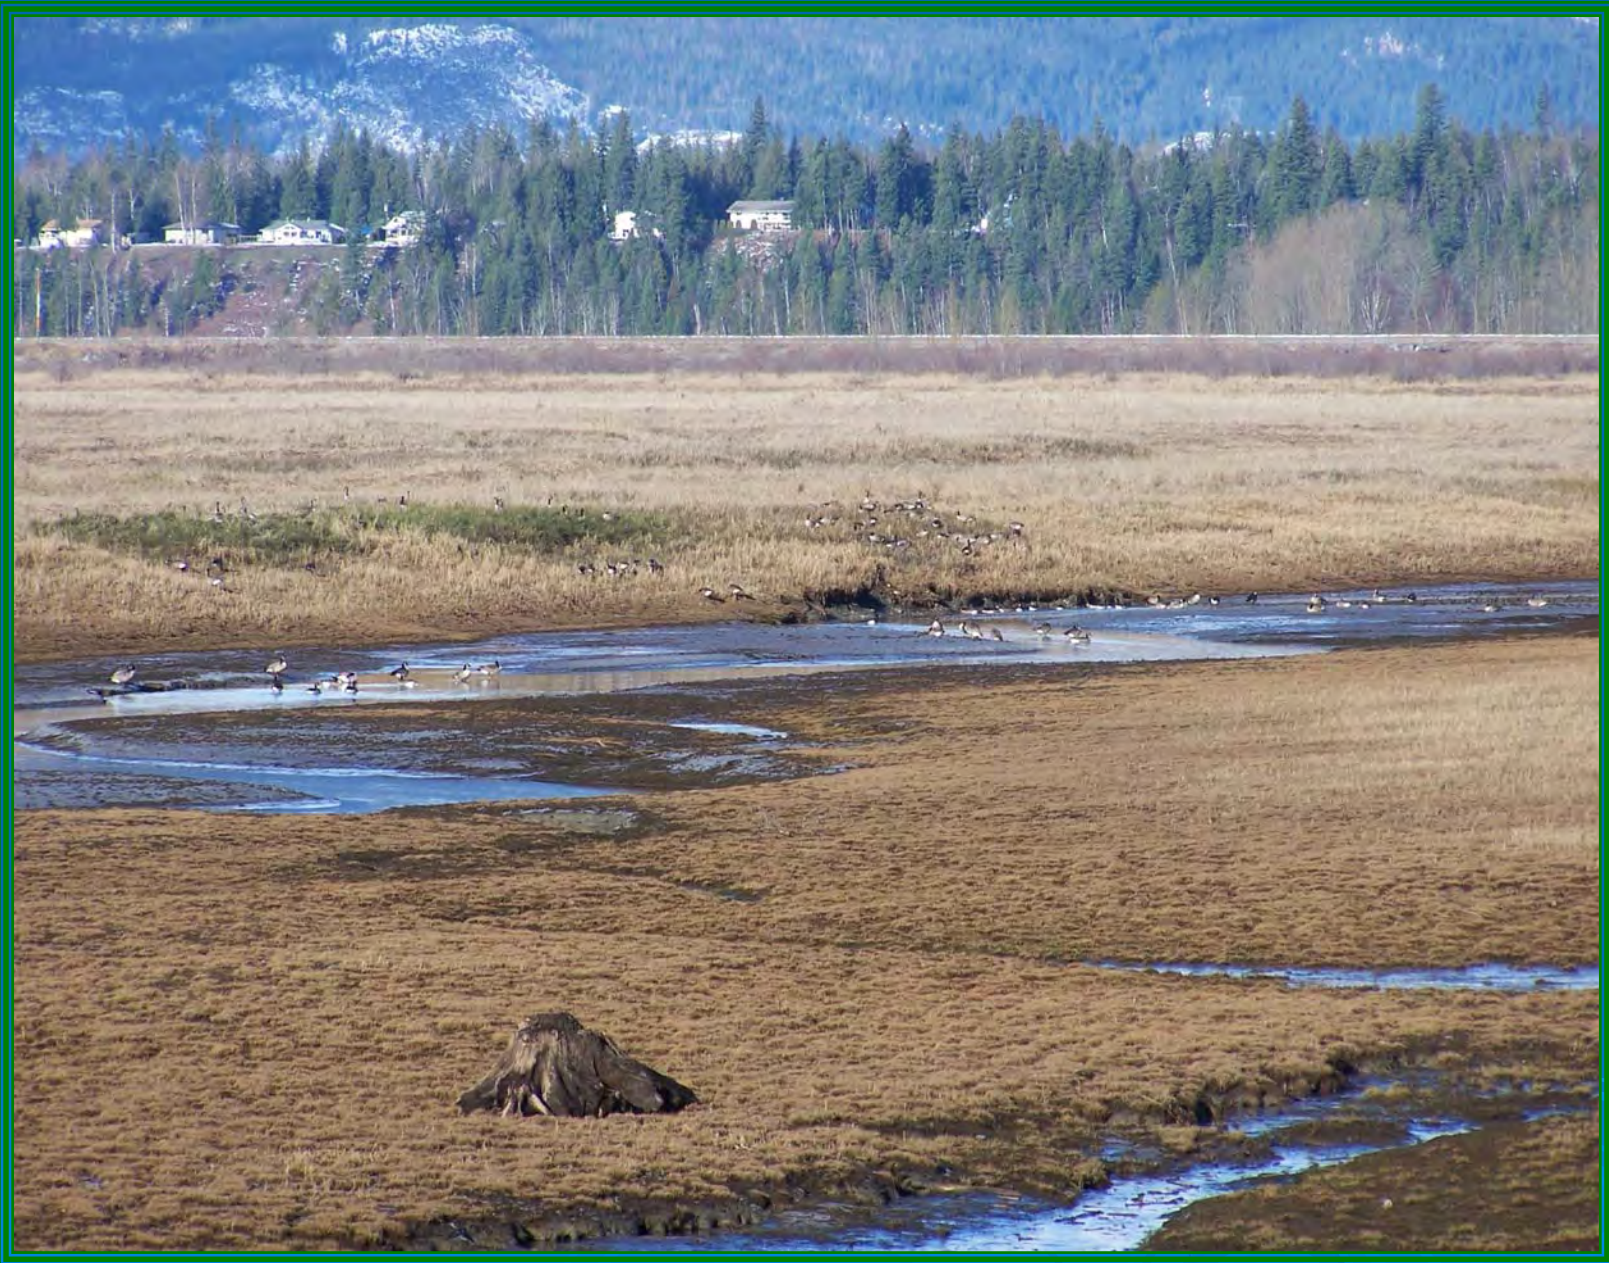
Locke Creek, fall 2009 – 100 + Canada Geese feeding on scouring rush.

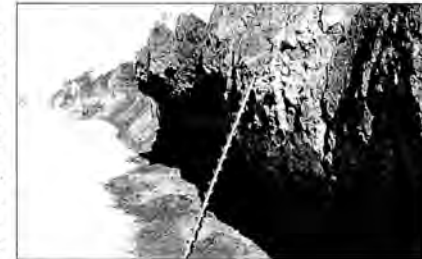
Figure 1. Banks are highly susceptible to failure upon thaw.

**This is a “signature” indicator of
peaking plant operations and
vegetation impacts, at the waters edge**

Soil freeze-thaw (FT) processes directly affect soil erodibility and bank-failure susceptibility (Fig. 1) (Gatto et al. 2001, Simon et al. 2000) and thus have substantial impact on shoreline or bank evolution, system-wide sediment management, reservoir infilling, levee stability, and sediment-bound contaminant transport within watersheds. This technical note outlines how FT cycling affects overland soil erosion and bank failure. In so doing, it alerts Corps planners, designers, O&M personnel, and water-resources modelers to the importance of knowing the magnitude of these effects on sediment detachment, failure, and transport in such cold-climate, navigable systems as the Mississippi, Illinois, Ohio, Missouri, Susquehanna, Delaware, Columbia, and Sacramento Rivers, and the Great Lakes and their connecting channels.

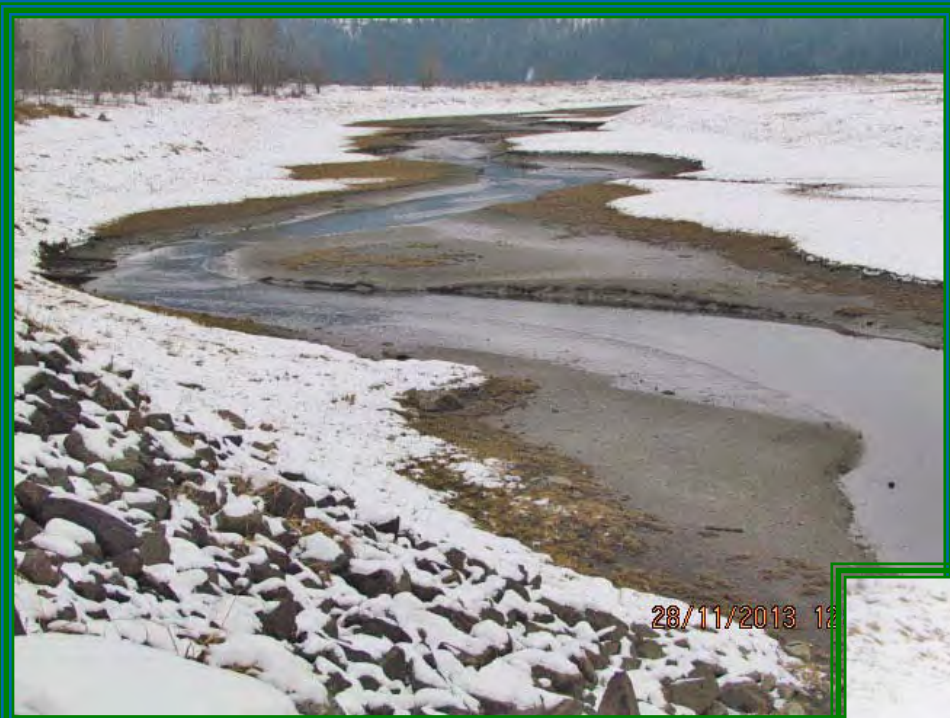
Nov. 28, 2013

**One of key the processes
at work in lower Locke
Creek and currently
effecting sedge vegetation
losses.**

- 1. Freeze/thaw overland erosion.**
- 2. Freeze/thaw bank erosion.**
- 3. Sedge/plant exposure to freezing weather when natural conditions would have vegetation snow covered through most of the winter season.**

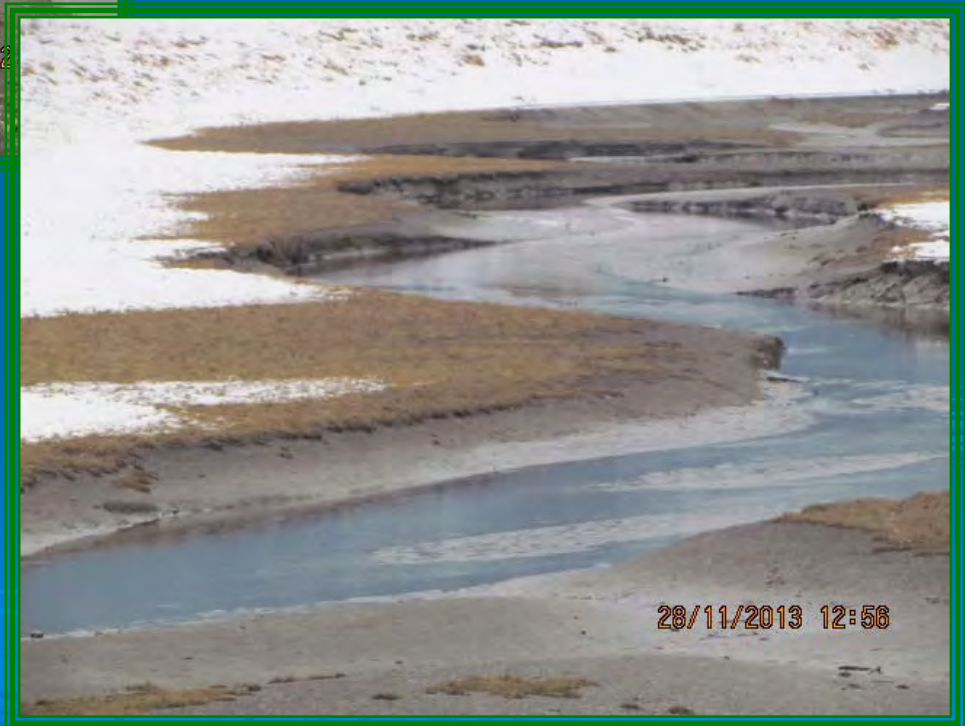
Sedge habitat veg. loss:

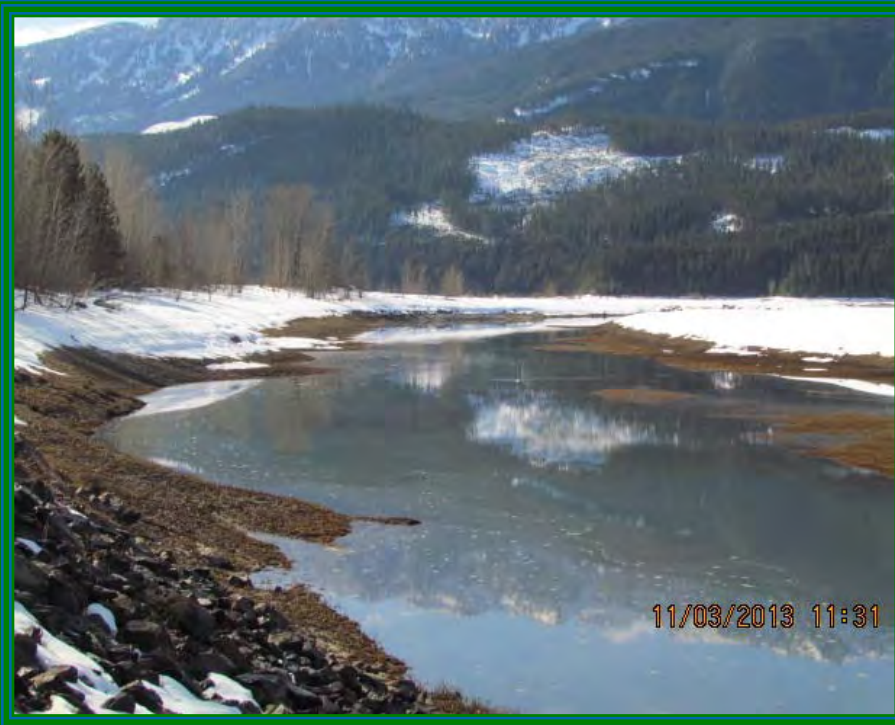
Locke Creek Feb. 11, 2013

Arrow res. @ Nakusp: **428.04**

Rev. Discharge: **25.8 kcfs average daily**

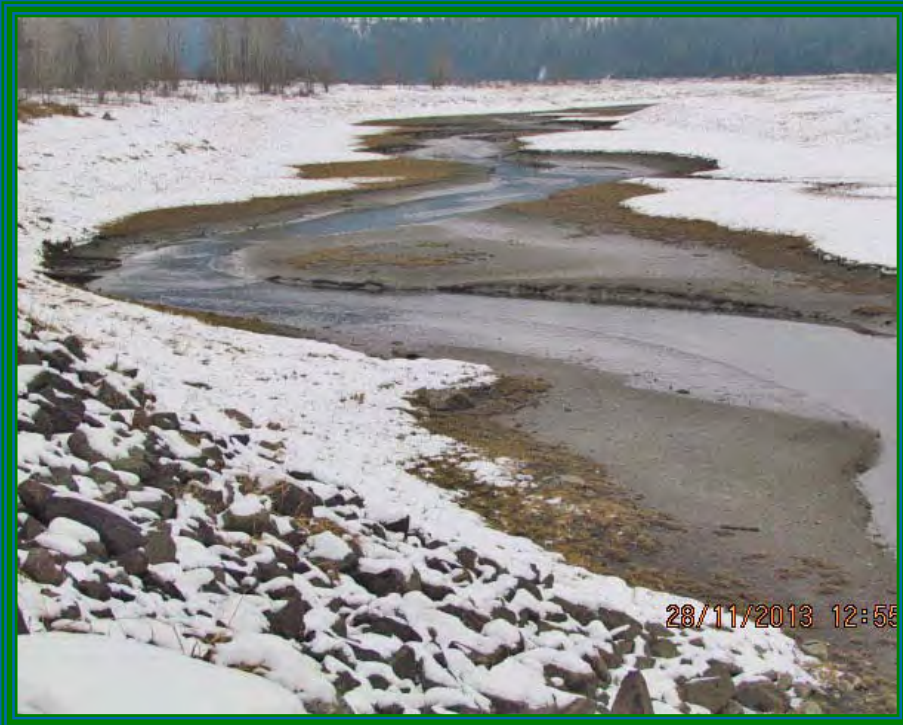
Locke Creek Nov. 28, 2013

Arrow res. @ Nakusp: **431.02m**

Rev. Discharge: **22.5 kcfs average daily**

Data and water levels in these images DO NOT compute??

Average daily discharge does not provide sufficient information.

**Instantaneous Rev. discharge data is required to properly
“calibrate” on site impacts, site by site.**

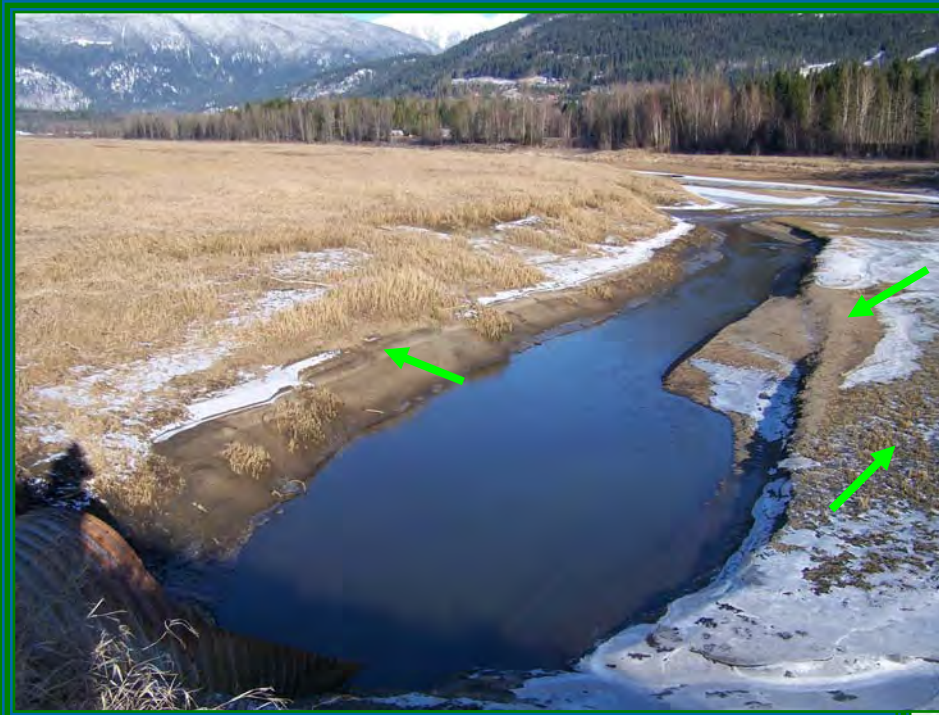
Feb. 13, 2008 ??
Locke Creek outlet

Arrow res. @ Nakusp:

13/02/08 – 432.07m 28/11/13 – 431.02m

Revelstoke Plant Discharge:

13/02/08 - 18.3 kcfs 28/11/13 - 22.5 kcfs

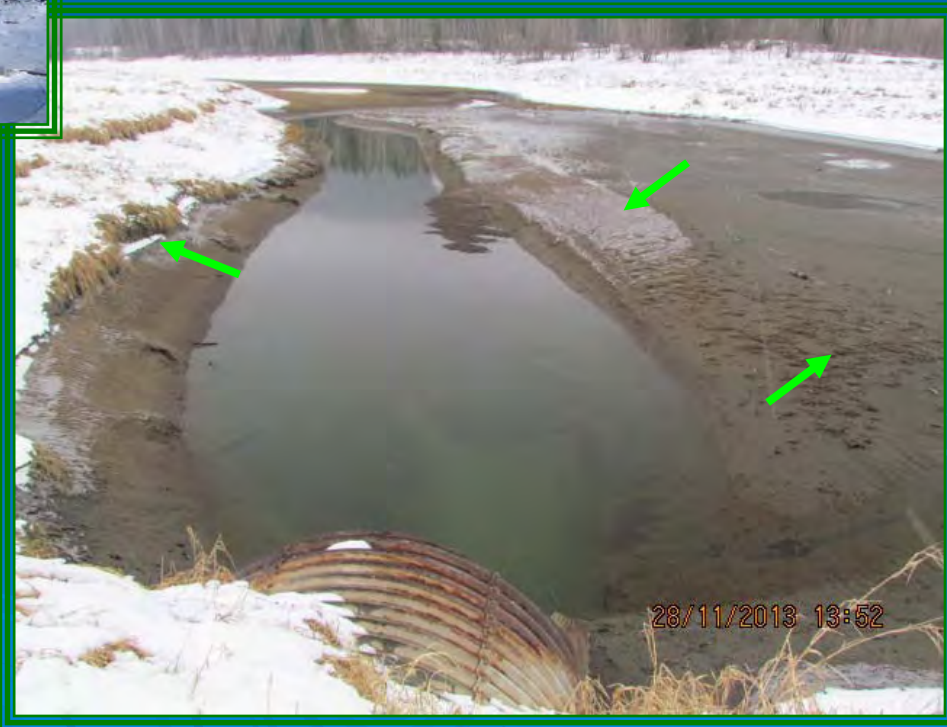
Note: Veg. free area - 2013.

While Sedge is flood tolerant,
permanently saturated soil does
not support sedge growth.

**Extending flood period may
reduce sedge cover.**

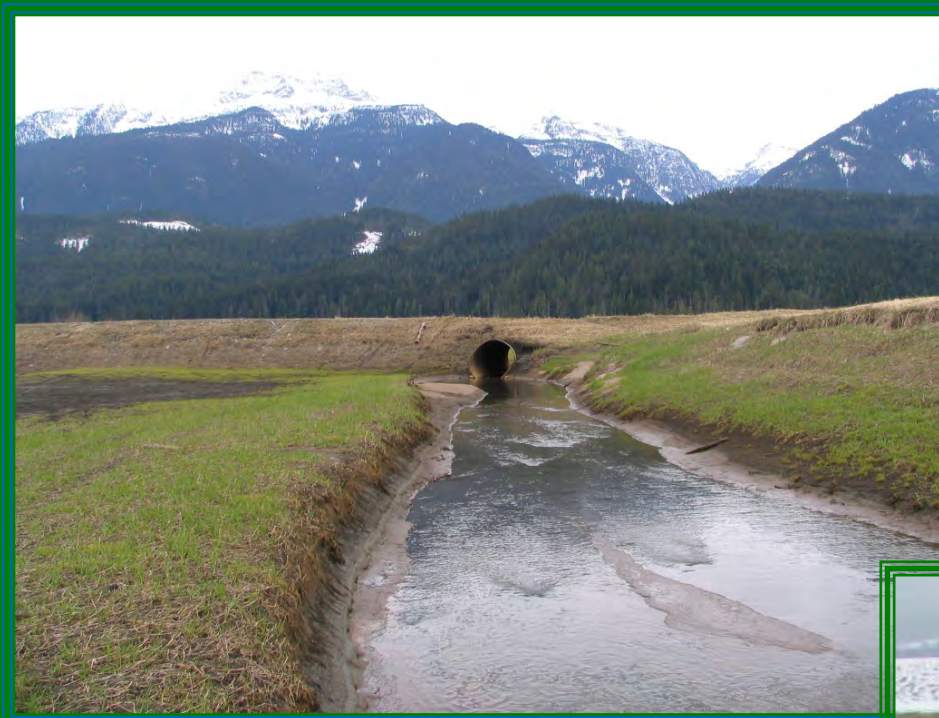
Locke Creek outlet

Between 2008 and 2013 (5 years) change has occurred here. The important point is that up to 2008 sedge density has persisted and relative channel stability has been maintained for 30 years with 4 units operating at Rev. Dam

The sedge loss here is the direct result of Rev 5 peaking operations. Rev 6 peaking will increase erosion impacts and likely veg. losses.

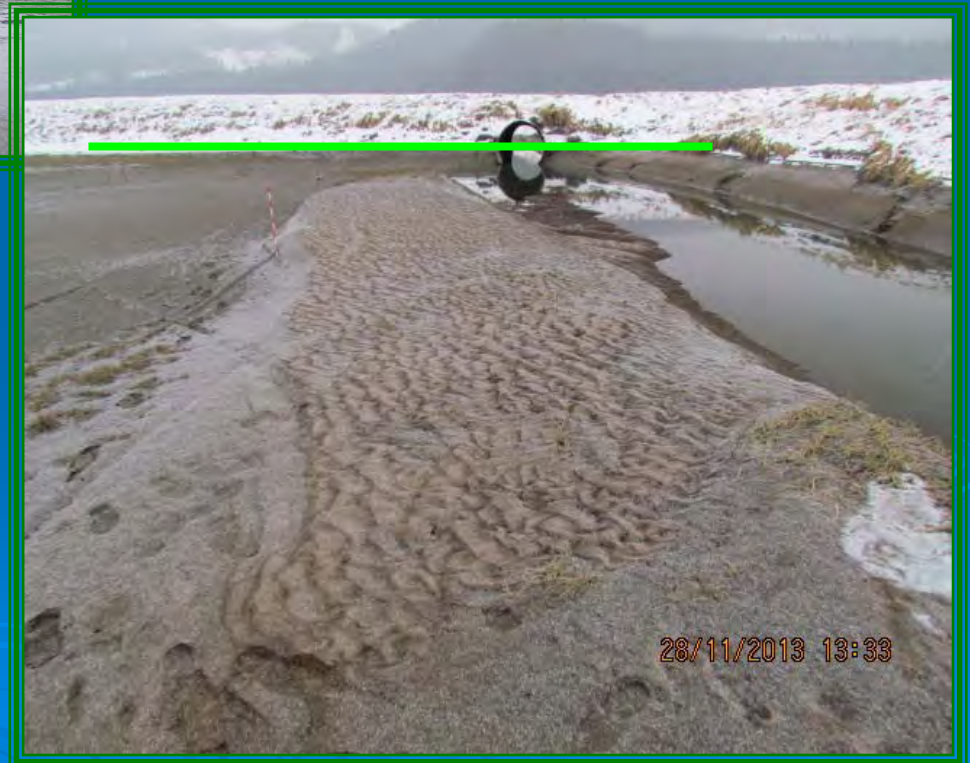
Newly deposited sediment, below, is as a result of a peaking plant “surges”, that have scoured out of the channel and “blown” sediment upstream approximately 100m.

Above snow line is accumulation between

Nov. 16 – 28, 2013. Area below snow-line is snow free due to peaking plant operations and is exposed to freezing temperatures.

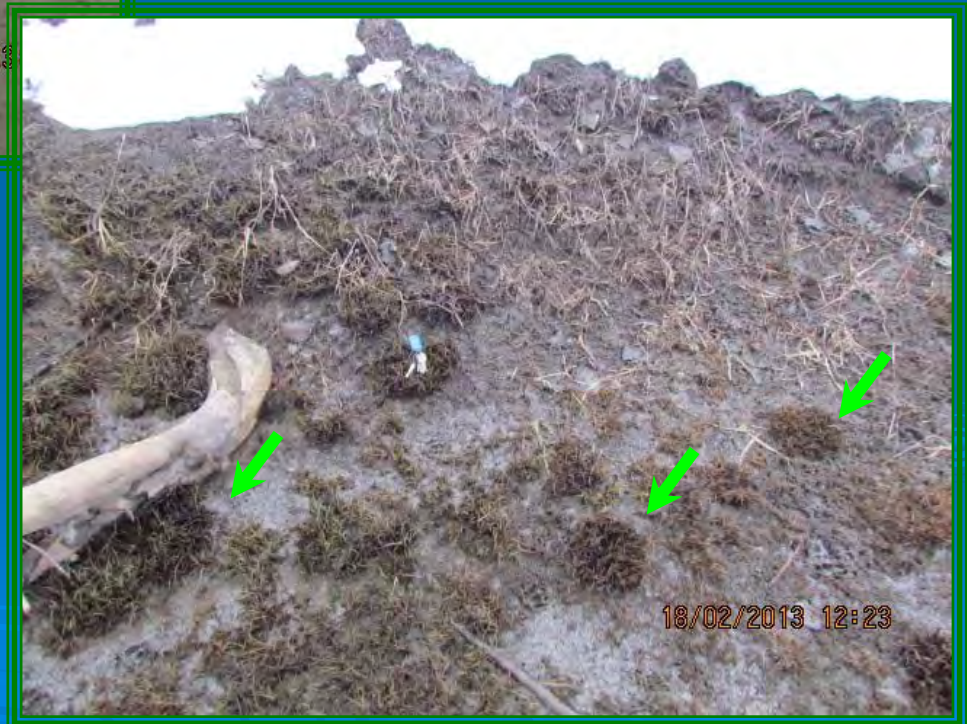
Upper Locke Creek

1. Freeze/thaw overland & bank erosion
2. Sedge **"Pedestaling"**: overland erosion removes soils from around plant's base & expose roots to freezing temperatures & desiccation/drying.
