planning
architecture
culture & heritage

MANUAL TRAINING & HOME ECONOMICS BUILDING HERITAGE ASSESSMENT

October 2013

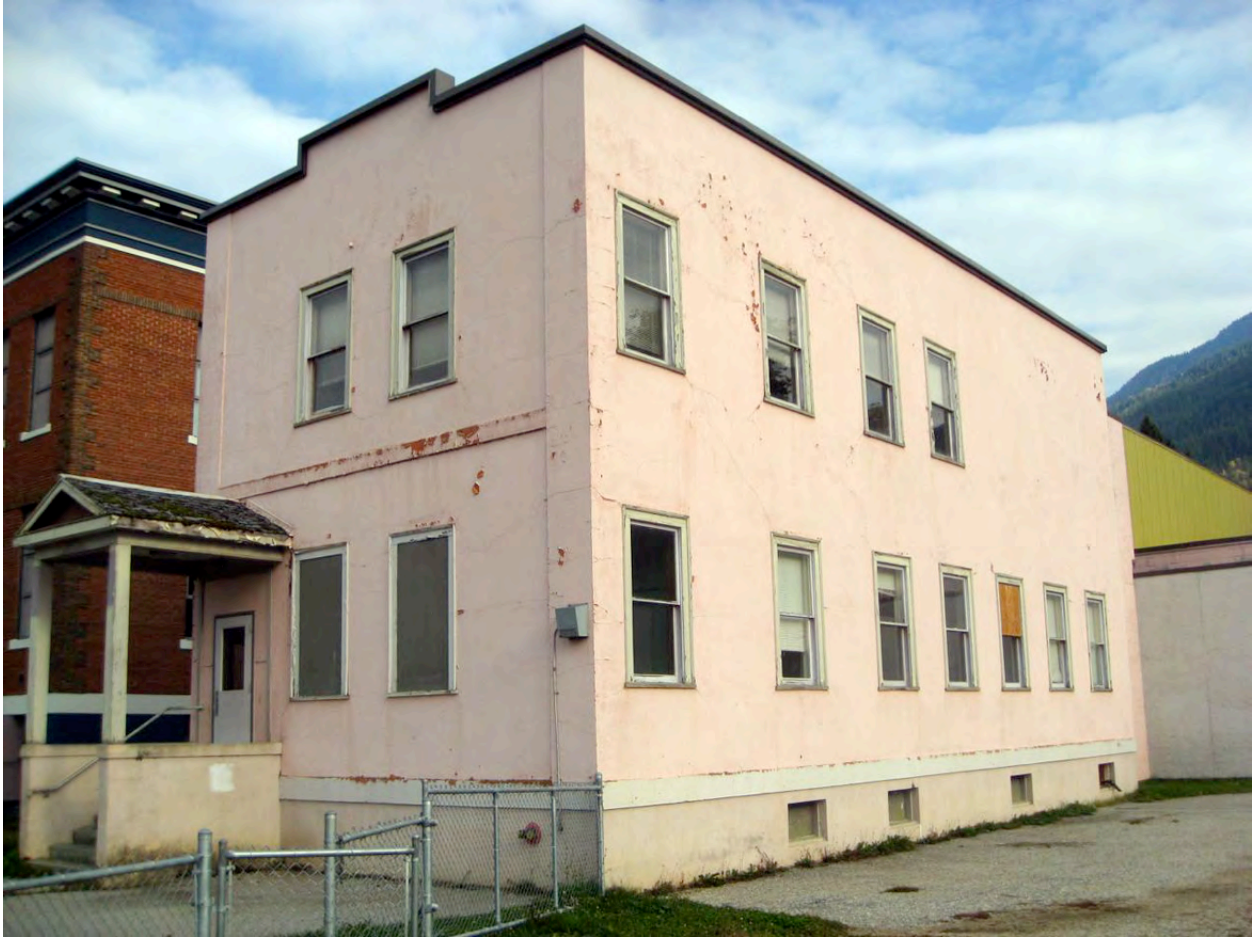
The exterior of the building is in poor repair, with extensive cracking of the stucco and deteriorated paint and window frames. Some windows have been blocked in, and the window frames are in very poor repair. Elements of the front porch have been rebuilt and replaced. The front door is a modern metal assembly.

Given the modest nature of this building, its utilitarian architecture, land opportunity costs and high costs of rehabilitation that would produce only a small amount of usable floor area, it is not recommended that this building be retained as a heritage site.
